WATERFRONT REVITALIZATION AREA BOUNDARY

VILLAGE OF SAUGERTIES, NEW YORK
 Shuster Associates * Planners

II. INVENTORY AND ANALYSIS

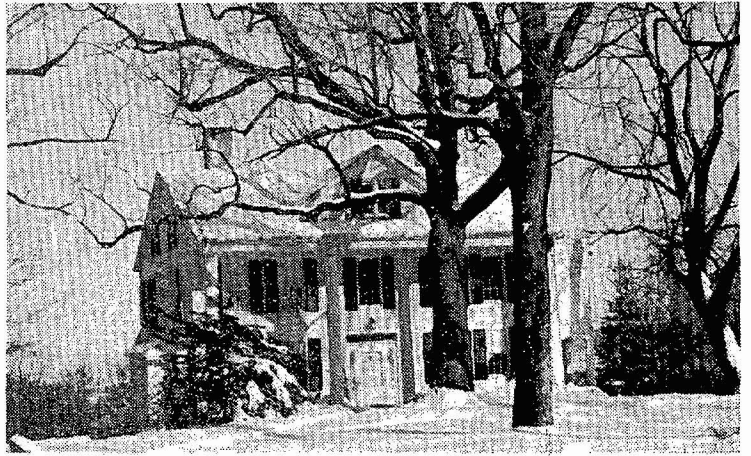
PHOTO #9: The "Bindery",
the last industrial
building ↘

The only large residential neighborhood within the coastal area is the Southside neighborhood which extends up the slope from the Creek to the ridge line traversed by Route 9W. This neighborhood developed in direct relation to the waterfront industry of the 19th century. It includes a variety of housing types - from modest workers homes to large mansions (see Photo No. 8) - as well as several public buildings and the one remaining vacant industrial structure (see Photo No. 9).

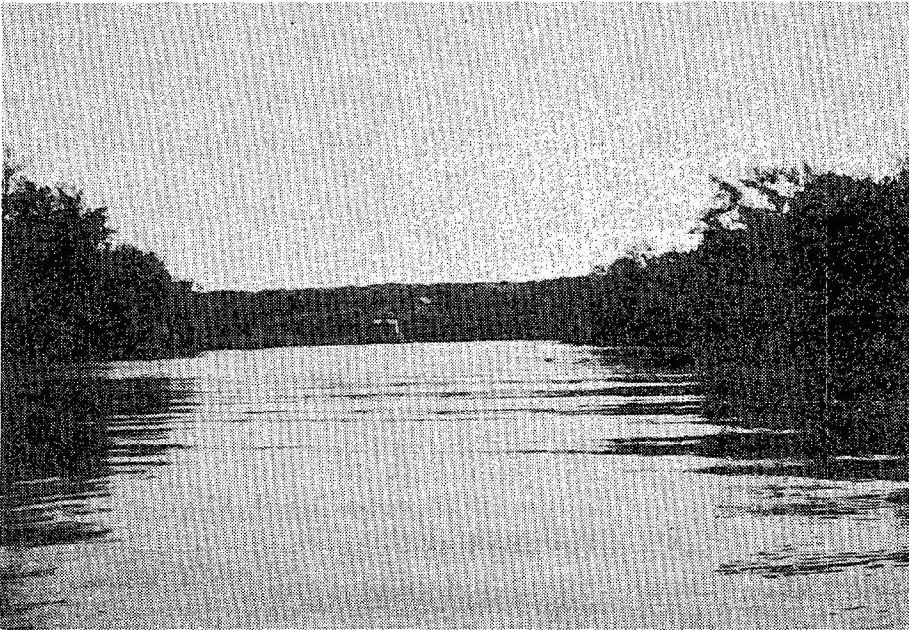
PHOTO #12: State-owned
wetlands at the
mouth of the Creek
↘

No place along the Village's more than four miles of waterfront is the public entitled to gain access to the water. The only publicly owned land is the wetlands owned by the State of New York at the mouth of the Esopus Creek (see Photo No. 12). These are fragile, ecologically important areas which are only accessible by water. Thus most of the Village's residents are deprived of the use of one of its most important assets.
