Town of
Erwin

Village of
Painted Post

Village of
Riverside

Step 2 Nomination

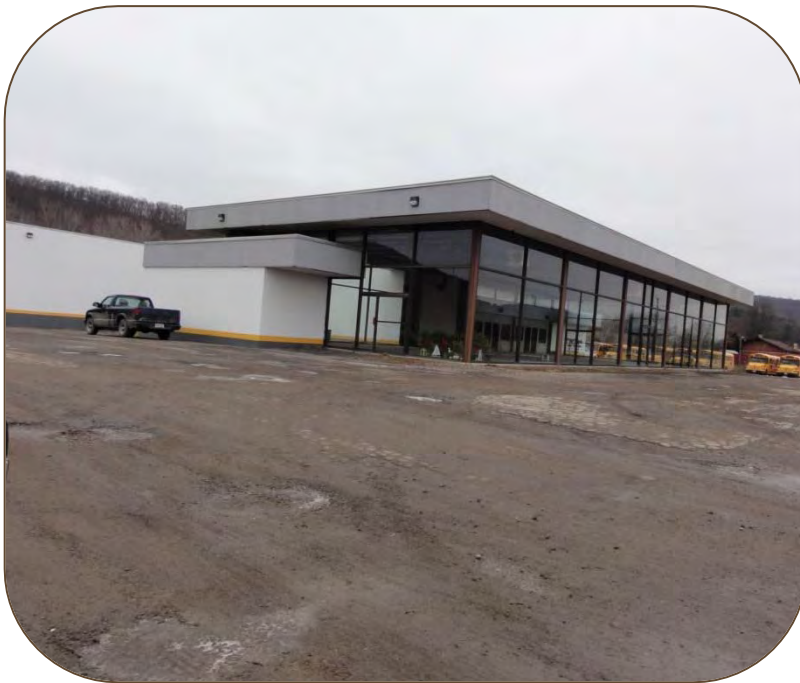
Strategic Site A was selected because of its location proximate to the highway interchange. The site is comprised of two parcels, 124 Victory Highway, owned by T&K Realty and 130 Victory Highway, owned by GBR Three AC LLC. Tax map ids are 280.00-1-12 and 280.00-1-56. The two parcels, which are a total of 8.06 acres, are located on the north side of Victory Highway just west of I-86 Exit 43 in the Town of Erwin.

124 Victory Highway has a 37,359 square foot commercial building with an asphalt parking lot. There is a drainage swale at the back of the property. The building is currently being used as a bus garage and dispatch facility by Birnie Transportation Services. There is a 10,000-gallon diesel fuel tank and a 1,000-gallon gasoline tank on site; containment measures are in place on both. Volatile organic compounds were once detected on the site, leading to the removal of an underground fuel tank; the degreaser trichloroethylene has been detected on site and several spills reported.

A Phase I ESA was performed on Strategic Site A by Hunt EAS.

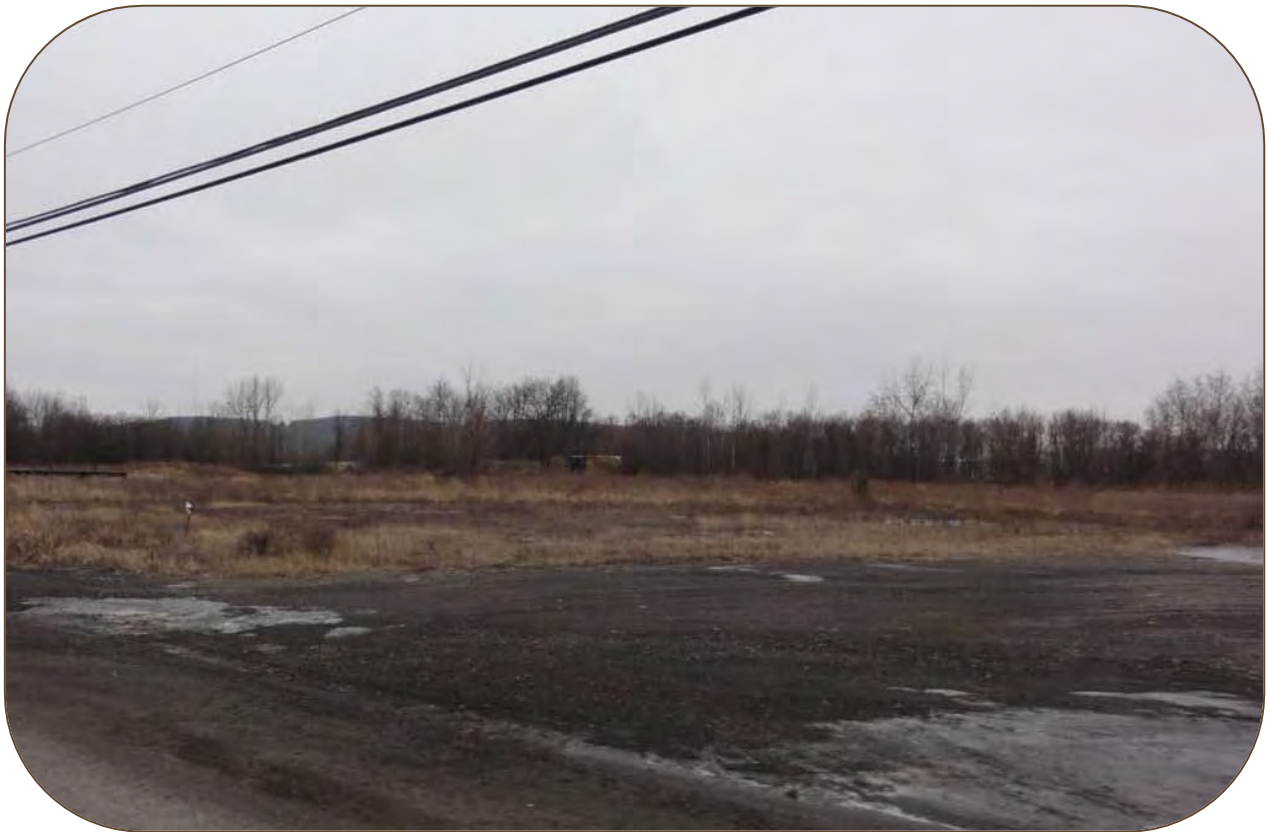
The site is vacant. There was once a building on-site used as part of a bridge construction project. Non-ignitable wastes were removed from the structure at one time. Aside from this incident, no other known reports have been issued on this site. However, conditions across the road at the former Painted Post Car Mart as well as known environmental records are located at higher elevation and could drain to the site. As a result Strategic Site B should be the subject of a Phase II ESA to determine what, if any, contaminants are present, how serious the contamination is and to develop a remediation plan.

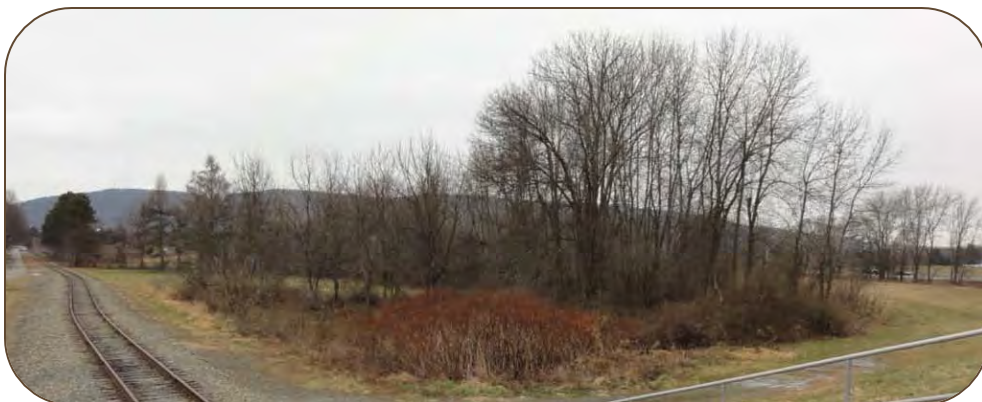
A portion of the site, 11.48 acres, is being redeveloped as a rail siding for a transloading facility the village will use to ship water to Pennsylvania for use in the gas industry. For that project, enhanced storm water management capacity and increased water service will be developed.

Any developer of Strategic Site C will need to be aware of, and work within, the framework for development set forth in the deed restrictions. No additional remediation or environmental studies are deemed necessary at this time, but they may become necessary at the time of development, when a specific use has been identified.

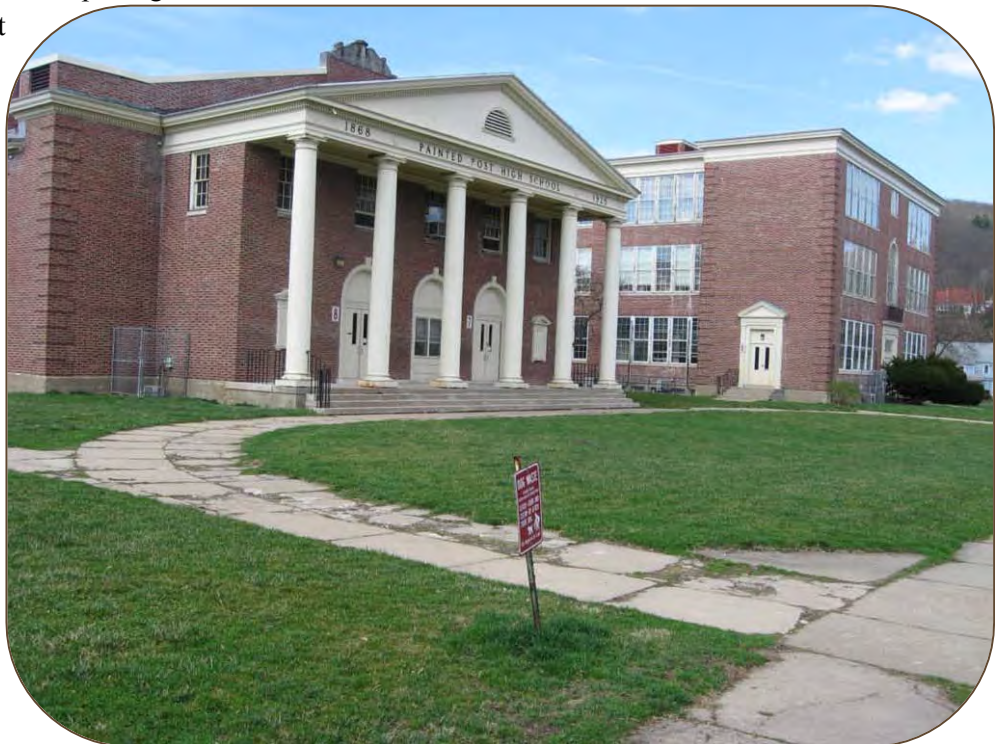
Strategic Site D

The building, interior and exterior, and the grounds have some serious signs of deterioration. The recommended residential reuse for this building would entail and should require a total rehabilitation.

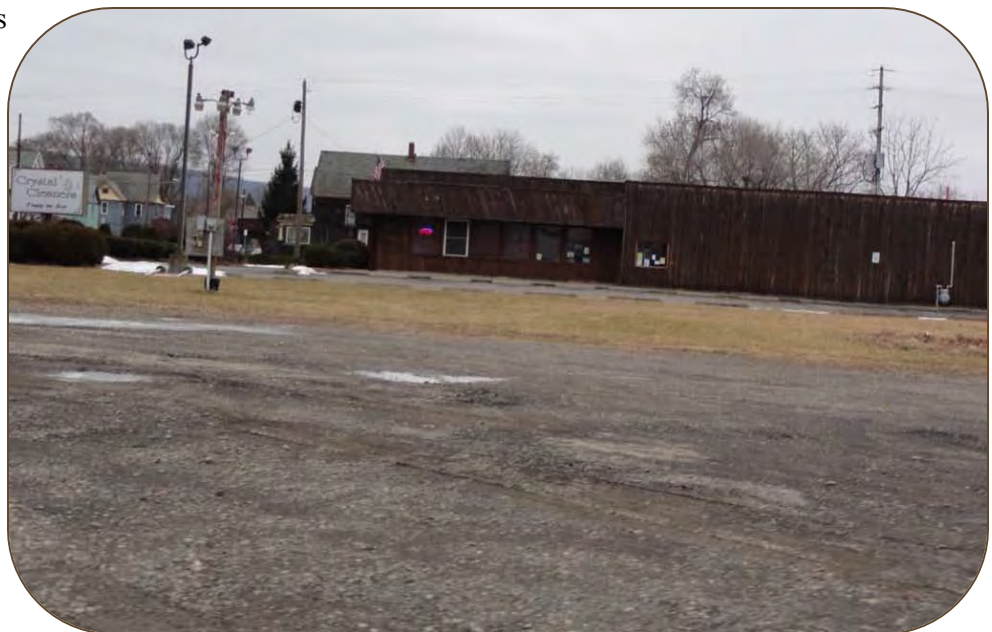
Strategic Site E was selected because it is adjacent to Strategic Site F and together they present the potential to create a big enough development opportunity as to be catalytic. Strategic Site E is a high visibility site with known and suspected environmental challenges. The site is comprised of multiple parcels and is located in the Village of Painted Post and the Village of Riverside. The tax IDs are 299.13-05-023.00, 299.13-05-021.00, 299.18-01-011.00, 299.18-01-012.00 and 299.18-01-014.00. It is located on East High Street between Hart and Bronson streets. It is approximately 2.68 acres. Strategic Site E is owned by High Victory Holdings. The Painted Post portion of the property is a vacant gravel lot; an auto parts store located on the site burned to the ground many years ago and all evidence of the building was removed. It has been vacant since. The Riverside portion of the site is occupied by Crystal Cleaners.

Strategic Site E is located in a densely developed area and no on-site environmental hazards were noted during Hunt's on-site observation. Among its former uses is as a used car maRoute The site is adjacent to or near five sites with environmental records and four listed sites. The listed sites are at a higher elevation of Strategic Site E, so they could have an impact on the site. Strategic Site E should be the subject of a Phase II ESA to determine what, if any, contaminants are present, how serious the contamination is and to develop a remediation plan. Hunt recommends a series of rehabilitative measures to bring the Crystal Cleaners building to ADA accessibility, and to meet current standards and needs. However, a better and more likely future use of the site would probably require demolition of the building.

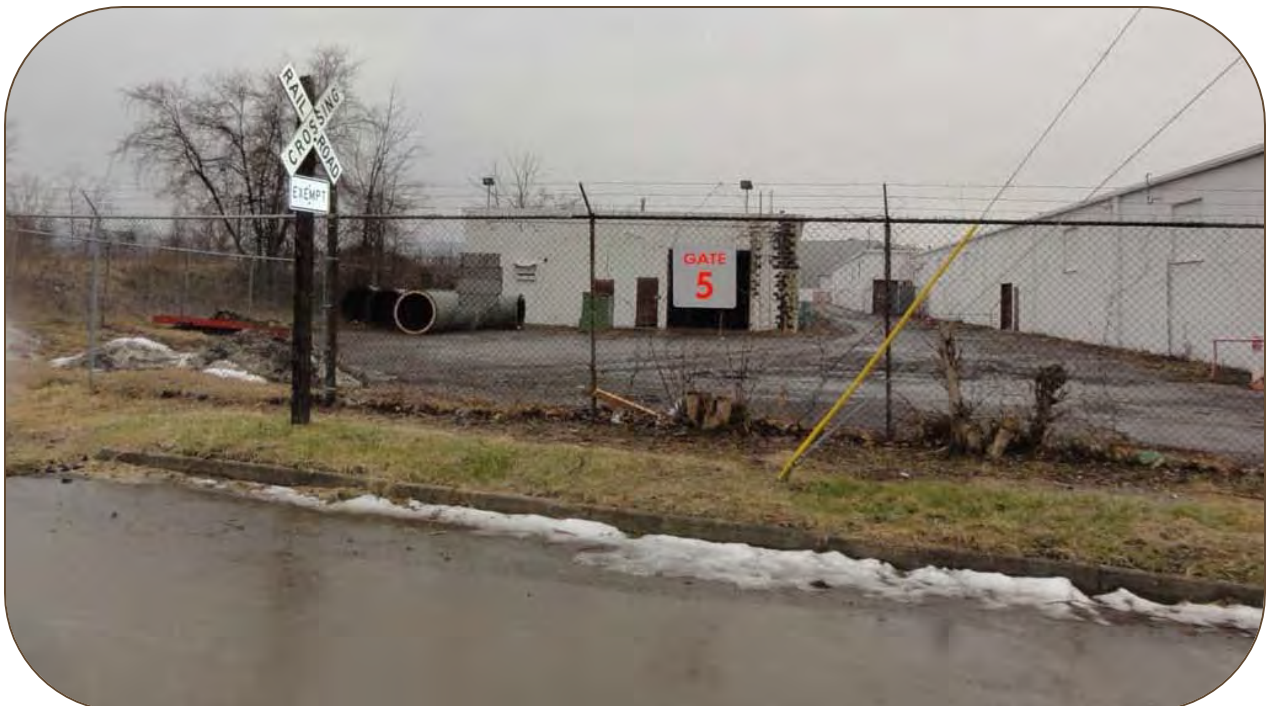
Strategic Site F was selected because it is adjacent to Strategic Site E and together they present the potential to create a big enough development opportunity as to be catalytic. Strategic Site F is a high visibility site with known and suspected environmental challenges. The 2.78-acre site is comprised of three concrete block storage buildings, a gravel parking area and some lawn all contained by a chain link fence and is located between Bronson and First streets in the Village of Painted Post on the Chemung Street Extension. The tax parcel ID number is 299.13-05-39 and the property belongs to Dresser Rand.

Strategic Site E is located in a densely developed area and no on-site environmental hazards were noted during Hunt's on-site observation. The site is adjacent to or near five sites with environmental records and five sites within one quarter-mile of Strategic Site F are listed. The listed sites are at a higher elevation of Strategic Site F, so they could have an impact on the site. Strategic Site E should be the subject of a Phase II ESA to determine what, if any, contaminants are present, how serious the contamination is and to develop a remediation plan. Hunt recommends a series of rehabilitative measures for the three concrete block buildings including new roofs for each of them at substantial cost. However, a better and more likely future use of the site would require demolition of the buildings.

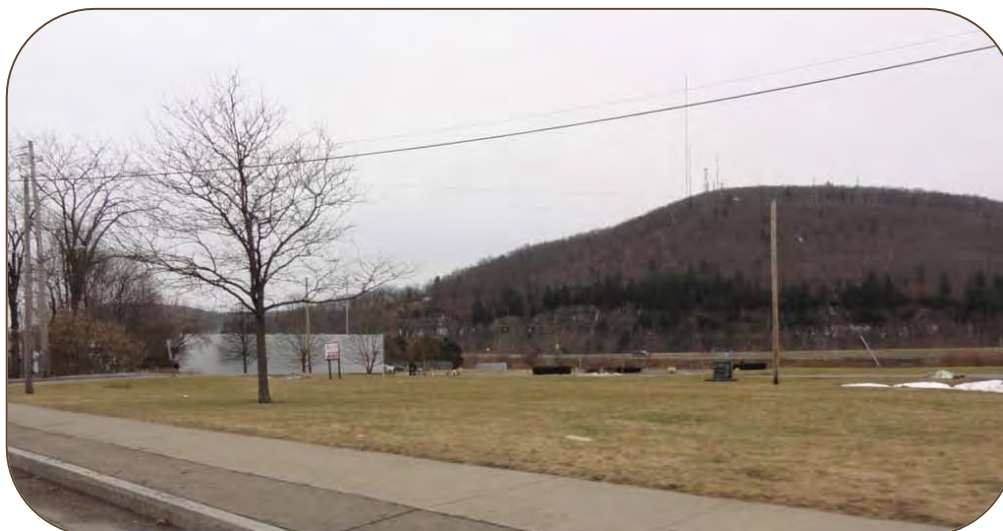
Existing outparcels adjacent to the site include tourism and business traveler amenities including lodging and food establishments. More of these kinds of services would add to and diversify the mix of tourist and traveler amenities with high visibility from Route I-86.

There were no spills or contaminants visible when Hunt did its site inspection. However, numerous environmental records were noted west and northwest of the site from which water would drain toward this site. The records include underground tanks that have been removed, a spill at a nearby gas station and known contaminants at the nearby Foundry site – Strategic Site C. Additionally, numerous sites with environmental records are located nearby and at higher elevation including a former dry cleaning establishment, gas stations and auto repair shop. Strategic Site G should be the subject of a Phase II ESA to determine what, if any, contaminants are present, how serious the contamination is and to develop a remediation plan if needed.

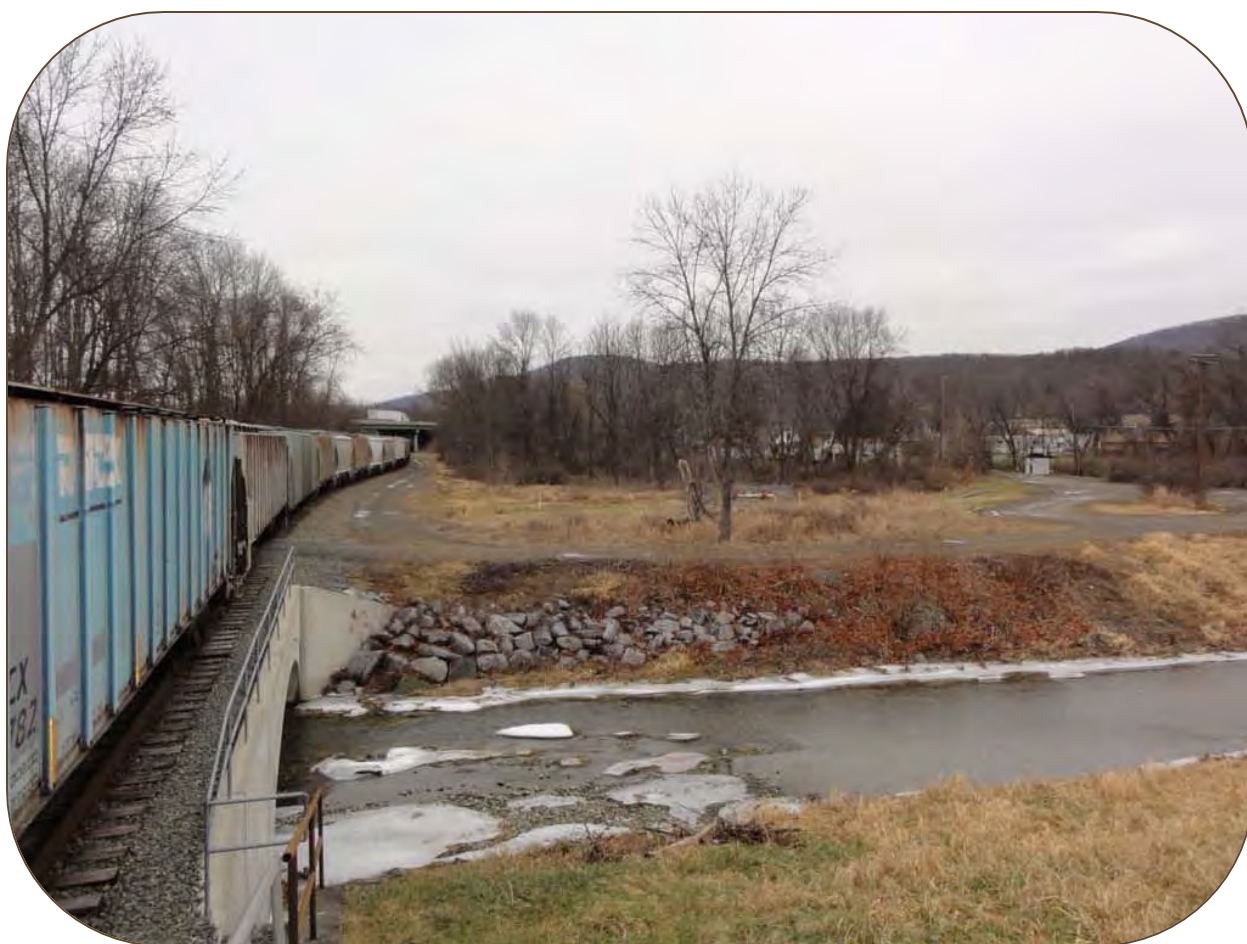
Strategic Site H is a collection of mostly residential properties just west of and over the tracks from Strategic Site C. It has become known as the “Bridge Landing” as it is the west end of the proposed access bridge for Strategic Site C.

As the bridge construction nears reality, an acquisition plan and site assessments should take place. To facilitate the bridge, Phase I and II assessments for the Strategic Site H group should be part of the BOA Step 3.

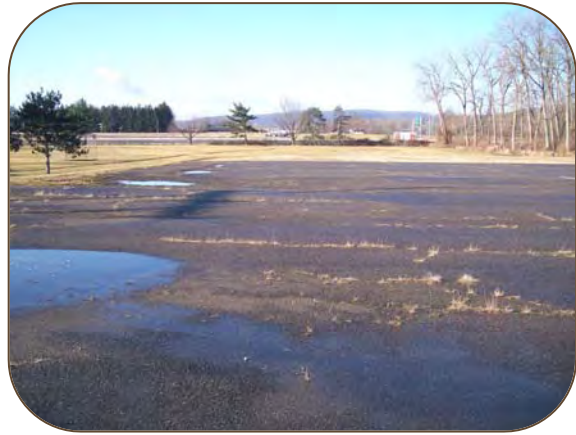
Existing Site C

Strategic Site C, the former Ingersoll-Rand Foundry site, consists of approximately 45 acres within the Village of Painted Post and is the single largest underutilized area identified within the Erwin/Painted Post/Riverside Brownfield Opportunity Area. This area is bounded by the Bath and Hammondsport Railroad to the east, a flood control project at Hodgman's Creek to the north, Interstate 86 to the west and Hodgman Park and residential development to the south. The former foundry site included a foundry building which was approximately 287,000 square feet which operated from 1920 through 1985, to produce gray iron castings principally for the Ingersoll Rand compressor plant. The operations consisted of pattern construction, sand mold lines, melt furnaces, castings, shakeout, clearing and pattern storage. After the foundry was idled in 1985, an environmental evaluation and cleanup was conducted by the Ingersoll-Rand Company as part of its facility closure activity. Government agencies and the Ingersoll-Rand Company conducted investigations at the site and according to a report prepared by NYSDEC (Division of Hazardous Waste Remediation) dated March 1994, the Record of Decision presented a selected remediation for the foundry inactive waste disposal site. The selected remedial action plan at the premises was the recording of a deed restriction identifying the presence of certain environmental conditions at the premises.

The construction of a railroad siding which will be parallel and adjacent to the existing Bath and Hammondsport Railroad and which will run for nearly the entire length of Site C, is currently under construction. The purpose of this siding is to load tanker cars with water for use in the gas exploration industry in northern Pennsylvania. This siding will use nearly 12 acres of Site C, leaving approximately 33 acres available for future development. This study addresses access to those remaining 33 acres of Site C.

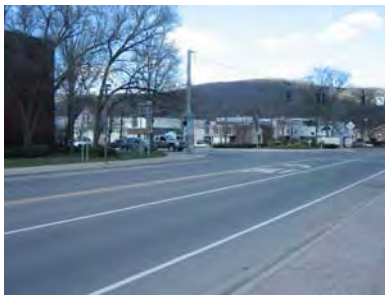
North Hamilton Street at W. Water St.

The sole highway access to Site C is from Hamilton Street to West Water Street, into the southern portion of the site. This route traverses the Painted Post village center, makes a right angle turn and then passes through a residential area alongside Hodgman Park; as a result, it may not be suitable for a large amount of truck traffic. This access was a previous source of contention within the community, of which many residents were opposed to its use as the primary access for a new development. It was determined that a second access route should be developed to accommodate a variety of proposed land uses for this site, particularly those uses resulting in a significant amount of heavy truck traffic. This determination was supported, previously, within the Interstate 86/99 Economic Development Blueprint, which recommended the reconnection of West Water Street through Site C as a means to stimulate redevelopment.

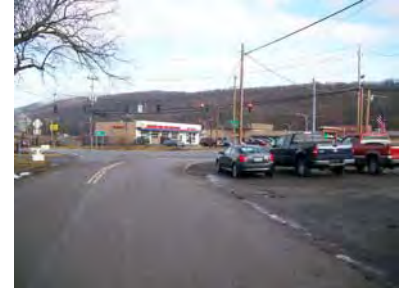
W. Water St. at Rte 415

- **Alternative 1:** Access from Route 415 southeast of its interchange with I-86 using West Water Street (north). This would require construction of a new bridge over Hodgmans Creek, the B&H Railroad and the flood control dike south of Hodgmans Creek to a touchdown point in the northerly section of Site C.

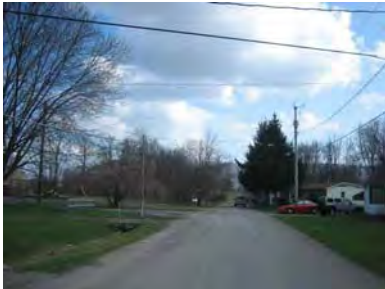
W. Water St. Looking South

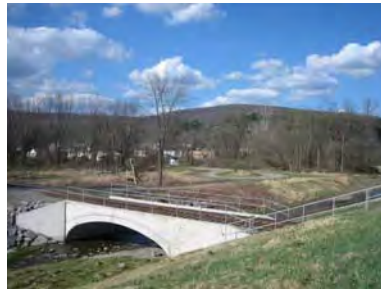
Approx. Bridge Alignment

A roadway alignment and profile meeting all of the above criteria was then developed as shown on the attached plan and elevation views. The resulting bridge is expected to be a three span continuous, steel multigirder structure with a span arrangement of 90'- 120'- 90' with the center span crossing over the main creek channel and railroad. The northerly span will cross the flood plain north of the channel and help to minimize the placement of fill material within that area. The southerly span will cross over the dike. The piers and abutments of the bridge will be supported on pile foundations to protect them from scour and to prevent settlement from occurring. The roadway width of the bridge will be 34' – 0" and the barriers on either side of the bridge may be either steel railing on curbs or concrete barrier in order to control the surface drainage on the bridge and direct it away from the railroad. No sidewalks or bicycle lanes are planned to be carried across the bridge. Lighting is considered optional and is not currently included in the estimate.

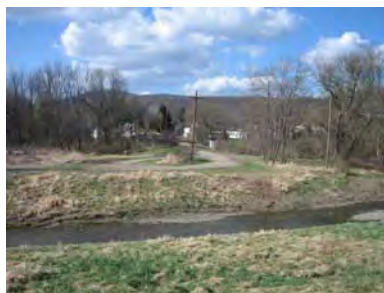
- **Alternative 2:** Access from Route 415 and West Water Street (north), also requiring a new (but lower-profile) bridge constructed only over Hodgmans Creek and the flood control dike south of the creek. The proposed road would then connect with High Street. Access to Site C would be via a second road with an at-grade railroad crossing south of the dike, which would intersect with the West Water Street (north)/High Street connection just south of the dike.

Approx. Bridge Alignment

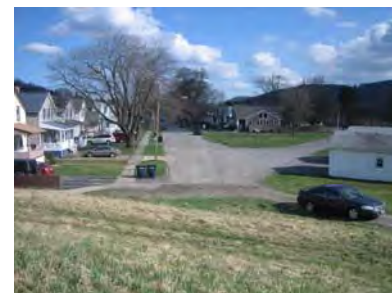
Tie in with High St.

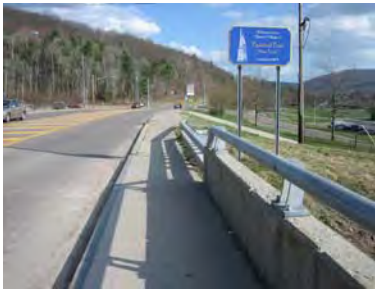
- **Alternative 3:** Access from Route 415 south of the bridge carrying Route 415 over Hodgman's Creek. A new roadway would be constructed from Route 415, parallel to Hodgman's Creek near Corning-Painted Post West High School. This road would utilize an at-grade railroad crossing south of the dike to access Site C.

Proposed Intersection at Rte 415

- This would force the intersection farther to the south and closer to the driveway into Corning-Painted Post West High School. The combination of horizontal geometry and elevation differences may actually force the access road to merge with the driveway into school or to cause the driveway to be relocated farther to the south. The access road would also cause the displacement of some of the on-campus roadways and parking at the school. Due to the concerns over the impacts to the school and the need for an at-grade railroad crossing, this alternative was dropped from consideration.

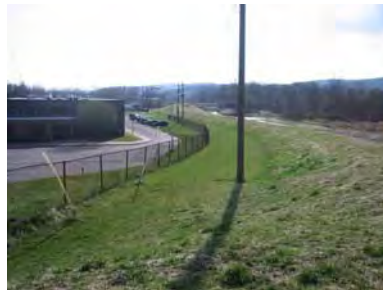
Alignment Along Creek

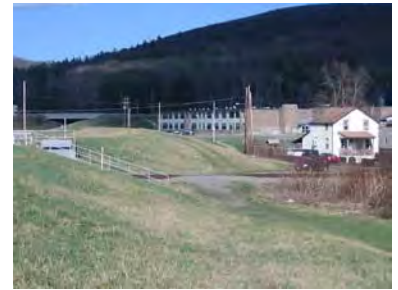
At-Grade Rail Crossing Location

Regarding the proposed rail crossing, a major concern exists in that if a new at-grade railroad crossing is approved for construction with public funds, one expected condition of such approval is a requirement that two other existing at-grade crossings be removed. We know of no existing crossings that could be sacrificed to justify the construction of this proposed new crossing. Therefore, it is likely that the at-grade crossing and the access road that would utilize it would not be feasible for this or any publicly-funded project. If a developer is interested in pursuing this option in the future, he or she would need to negotiate with the railroad regarding the private construction of the at-grade crossing and access road. A successful outcome for such negotiations cannot be guaranteed. For this reason, this alternative was dropped from consideration.

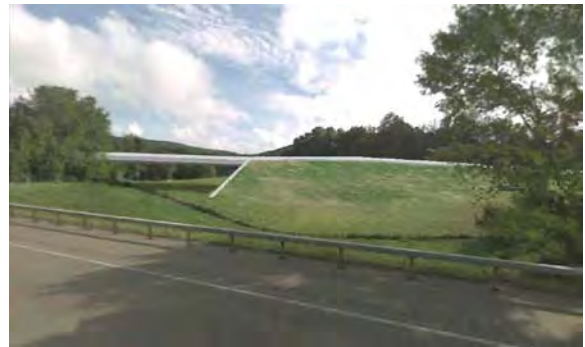
Figure 11: View from Interstate 86 of Proposed West Water Street Bridge

- **Alternative 1** would provide direct access into Site C and be designed to meet the hydraulic requirements for crossing over the Hodgman's Creek flood control project, thereby enabling New York State Department of Environmental Conservation (DEC) and the US Army Corps of Engineers (ACOE) to issue the permits required for construction. Vertical and horizontal clearances required by the railroad should also be achievable. West Water Street (north) would have to be reconstructed, requiring the acquisition of additional right-of-way, including two houses. This alternative meets the project objective and appears to be feasible for construction without significant issues so the analysis will be carried forward.

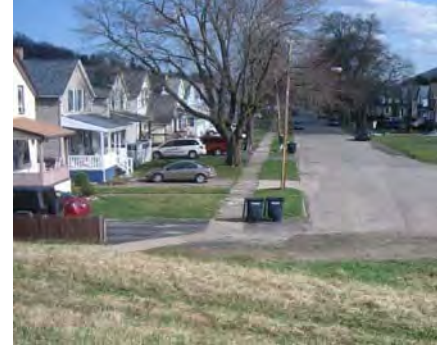
Affected Houses, Alternative 2

- **Alternative 2** would provide a second access into Site C. It would not be as direct as Alternative 1, since an at-grade railroad crossing would be utilized and an intersection between the access road and the West Water Street (north)/High Street Connection would be introduced. As with Alternative 1, the bridge would be designed to meet hydraulic requirements for the crossing of the flood control project (in order to obtain permits from DEC and the ACOE). West Water Street (north) would require reconstruction and the acquisition of right-of-way would be required along both West Water Street and High Street including several homes.

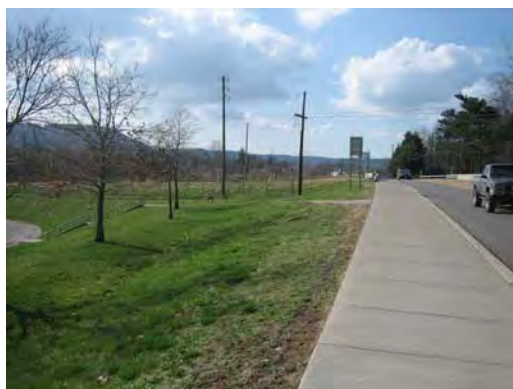
Elevation Difference at Rte 415 Bridge

- **Alternative 3** avoids the issue of the flood control project along Hodgman's Creek but retains the same concerns regarding construction of an at-grade railroad crossing as Alternative 2. Construction of an acceptable intersection between Route 415 and the access road would also bring about several issues. First, a significant difference in elevation exists between Route 415

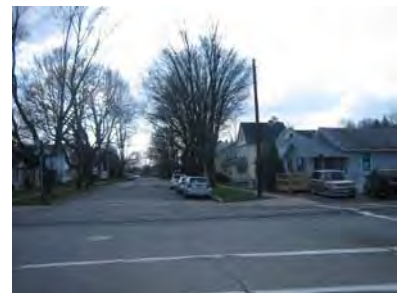
Affected Houses, Alternative 4

- **Alternative 4** would require trucks to pass through the Painted Post village center, similar to the existing access from West Water Street (south). Much of the right-of-way needed for this alignment would need to be acquired from the railroad, which may not be possible as the line is active. In addition, a rail siding is planned for construction parallel to the existing line in the near future. This siding will run nearly the full length of Site C, forcing the access road to shift to the west into a residential area as it approaches Site C from the south. For these reasons, this alternative was dropped from consideration.

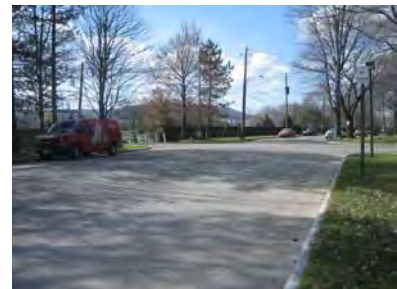
W. Water St. at Hodgman Park

- **Alternative 6** uses a portion of the existing access from North Hamilton Street to West Water Street (south), including the right angle turn, so it is not a fully separate access route. It then introduces another intersection with the turn into the Hodgman Park area and the route would continue along the perimeter of the park into the southwest corner of Site C. Construction of this route would require the acquisition of park lands which were created with the assistance of federal funding. Justification of this acquisition would be very difficult since another feasible option exists.

Even if it was determined that this alternative is the preferred option, the actual acquisition process for the park land would be a very lengthy procedure with no guarantee of a successful outcome. This alternative was dropped from consideration due to the need to acquire this park land.

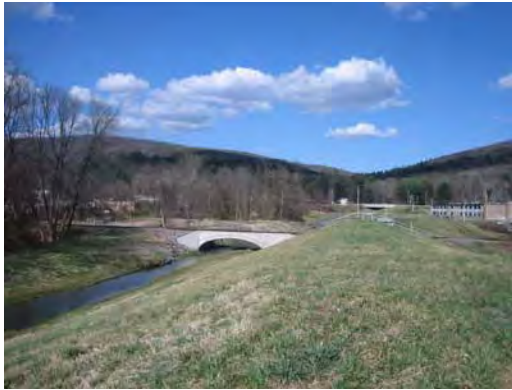
Corps of Engineers Flood Control Dike

Hodgmans Creek, in the vicinity of the proposed crossing, was determined to be a Class “C” stream by NYSDEC so it is not a fishing stream and does not have any in-stream restriction dates. This portion of the stream however, is within a U.S. Army Corps of Engineers Flood Control Project which is maintained by NYSDEC. As such, an Article 16 Permit for Use of Flood Control Lands will need to be obtained from NYSDEC with the possibility of needing the USACOE signing off on it. The proposed bridge will not require any relocation of the stream and the proposed piers and abutments will be located outside of the stream bed so the only potential in-stream work may be the placement of some heavy stone fill scour protection for the pier areas. This work will not impact the water surface elevations or the water quality.

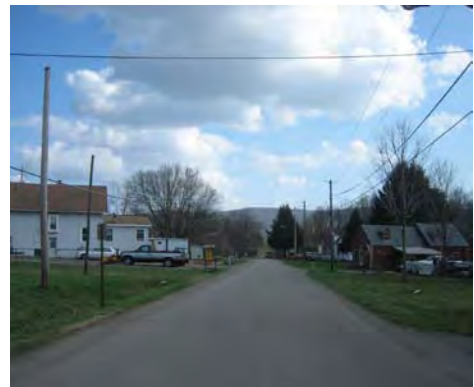
20' Pavement on West Water St.

With the design criteria calling for two 12' lanes with 5' shoulders as a minimum, the total required roadway width will be 34'. West Water Street (north) currently has only about 20' of pavement width and the structural capacity of that pavement is probably insufficient to handle heavy traffic. That entire section of roadway will therefore need to be reconstructed. The proposed roadway is expected to be constructed with a 12" gravel subbase, 6" of asphalt base and a total of 2 ½" of asphalt binder and top courses.

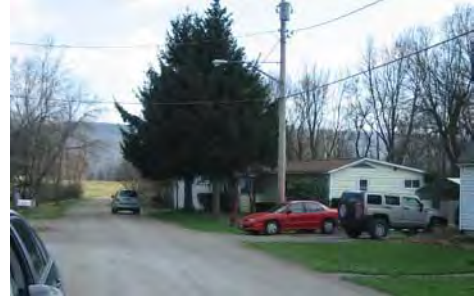
Affected Houses – W. Water St.

The cost of right-of-way for this access road is not included in the above Engineer's Estimate. These costs will include the cost of the property that the new portion of the roadway and its embankments will be constructed upon and the additional width of property needed to construct the widened and realigned West Water Street (north). It is expected that this right-of-way need will include the acquisition of two houses located on the west side of West Water Street (north) at the southerly end of the existing road. A dditional easements or acquisitions will also be necessary for drainage purposes and along the southern portion of West Water Street (north) to allow for the proposed highway embankments to be blended into the existing ground or parking lot elevations.

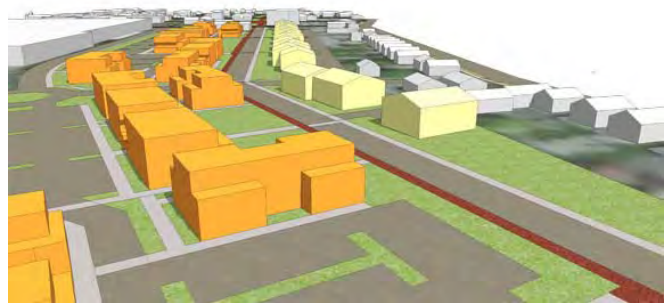
Walkable Urban Infill & Vistas

The new street will feature strong multimodal and pedestrian amenities, branching off of Hamilton Street, including sidewalks, landscaping and bicycle lanes. A strictly pedestrian connector will extend the new street from Steuben to Charles Street, terminating at the historic school building, serving as a visual and community anchor.

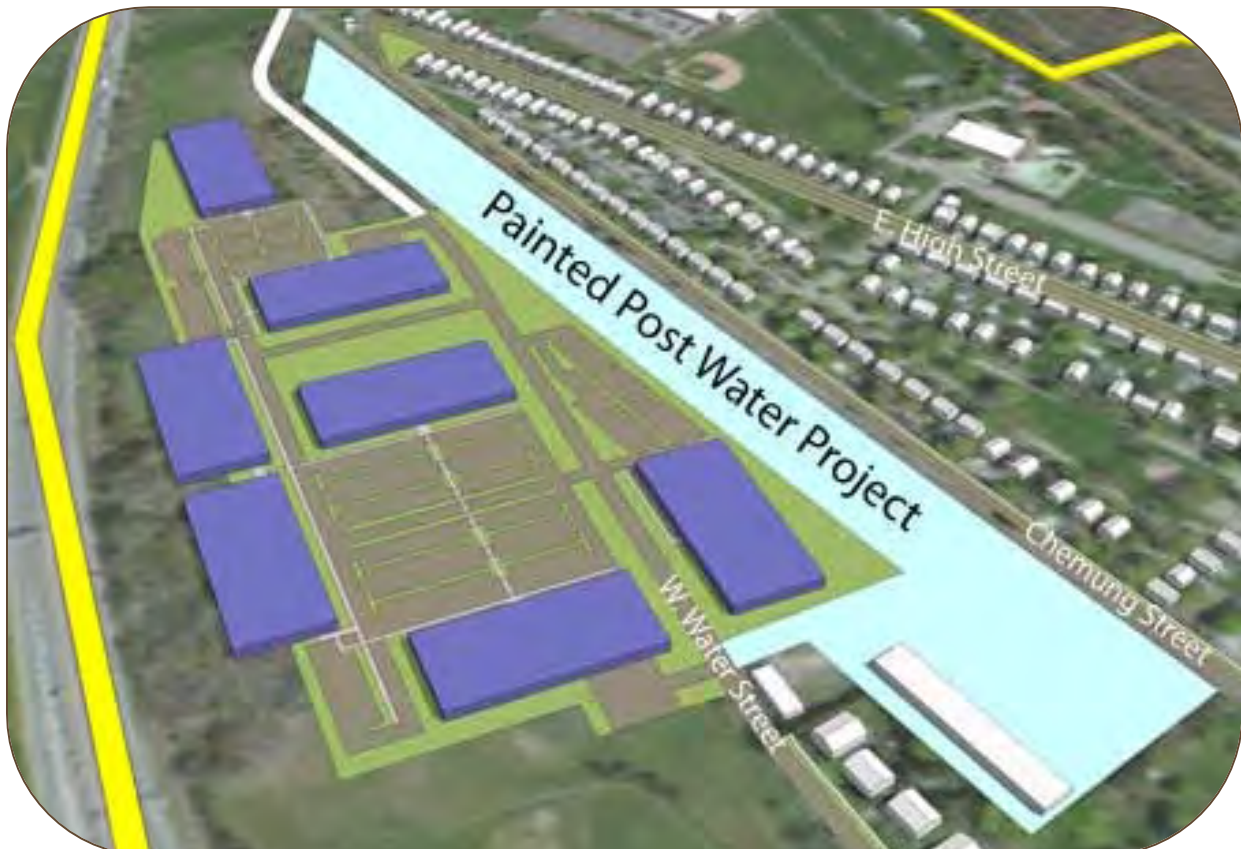
Industrial/Flex-Space Campus at Strategic Site C

Surrounding the new Commercial Mixed-Use are opportunities to continue the BOA legacy of industry and manufacturing. An industrial development corridor will stretch from one of the BOA to the other, centered around Hamilton Street and Hodgman Park. The southern end of the corridor, below the present Dresser Rand facilities, will be devoted to new industrial development. Existing pockets of residential development should be land-banked to create larger development sites for future industrial growth. Strategic Site C, the former Foundry site, will provide for more flex space than can accommodate a mix of 350,000 square feet of industrial and office development.

This area will be accessed by an upgraded W. Water Street through the site, with a possible connecting bridge at the northwest corner of Site C, linking into the northern section of Water Street and Victory Highway. The central location of the industrial corridor will provide similar support for commercial development in the downtown core, similar to the benefits experienced in the Village from the presence of Dresser Rand.

A major project recommendation of the BOA is to improve access to the study area's largest development site, Strategic Site C, the former Dresser Rand Foundry. A total of six options were evaluated in a Strategic Site C access report. Each was considered based upon the quality of access it provided, feasibility, potential costs and impacts to surrounding land uses. It was the recommendation of the report that a Bridge should be constructed in the northwest portion of the site, connecting Strategic Site C to West Water Street and, indirectly, to the interchange of Interstate 86. This option provides the greatest level of access with minimal impacts to the surrounding established neighborhoods. The estimated cost for this project is \$5.5 million. However, this cost should be considered in light of its potential to stimulate a substantial private sector investment into Strategic Site C.

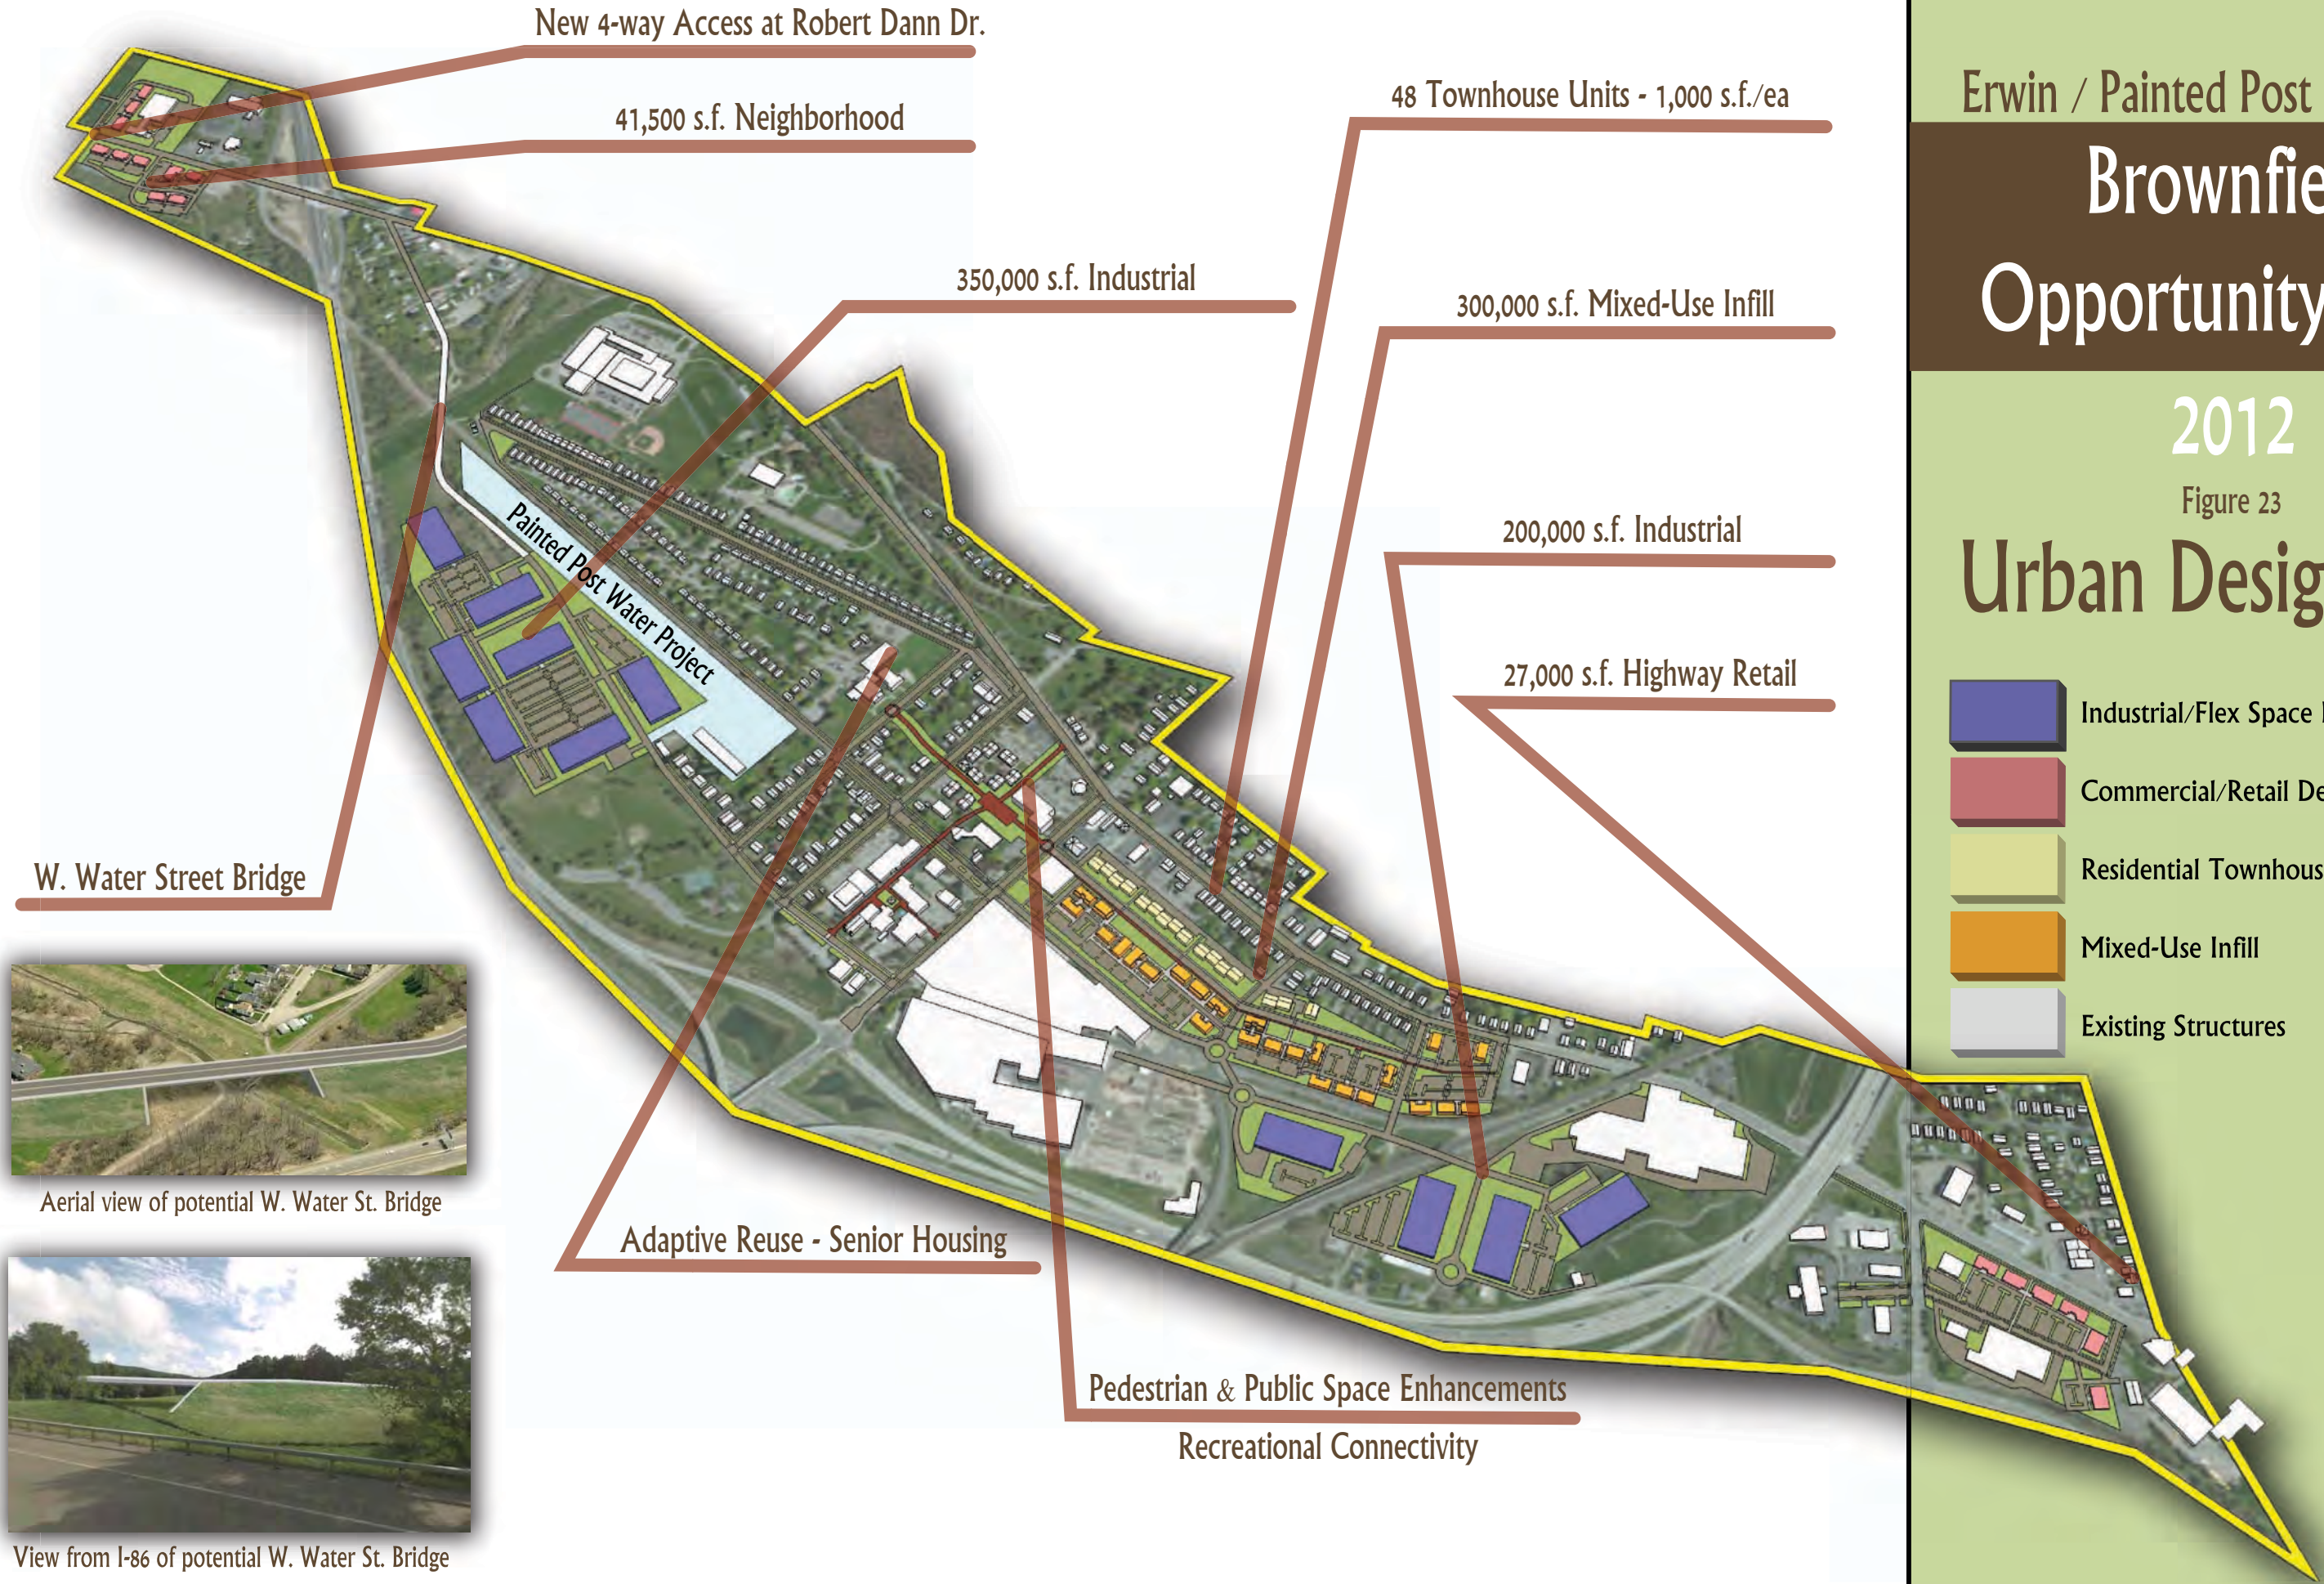
-   Industrial/Flex Space Development
-   Commercial/Retail Development
-   Residential Townhouse Development
-   Mixed-Use Infill
-   Existing Structures

The principle concept for the Urban Design Plan is to provide the physical conditions for the development of a diversified economy. The plan is organized with a systematic approach that unifies and strengthens the urban layout of the BOA project area. The future of the BOA will see new economic growth that sustainably revitalizes previously developed areas and supports social and community growth within each of the municipalities.
